**Flood Control Project Maintenance
Levee Inspections**
LMA District Cover Sheet
Spring 2017 Levee Inspection Results

Reclamation District No. 0307 Lisbon

Spring 2017 Levee Inspection Results

| Waterway | | | Bank | Unit Miles |
|--|---|---|---|---|
| Unit No. 01 Sacramento River | | | Right | 6.56 |

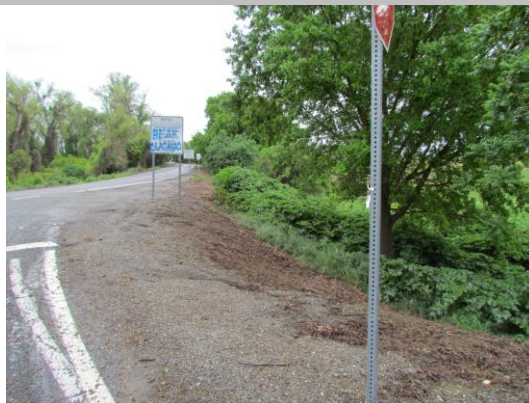
Photo 1 of 1 : SP_2017_RD0307_166_53_20170519_00107.jpg

RD 307 looking downstream from levee mile 0.00 landside slope.

| Control the annual grasses other than native from the slope and berm. | | | | | |

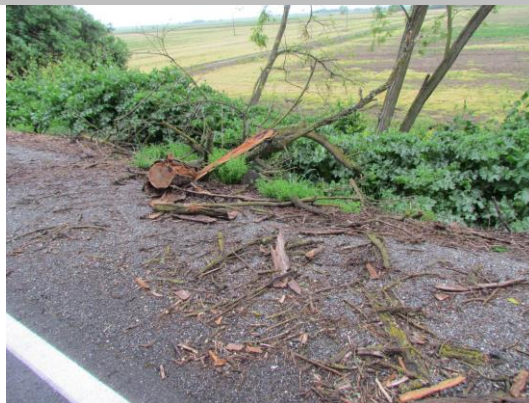
Photo 1 of 1 : SP_2017_RD0307_166_55_20170519_00109.jpg

RD 307 Levee mile 0.09 landside fallen tree on the slope and shoulder.

| Remove the cut up fallen tree from the waterside levee section. | | | | | |

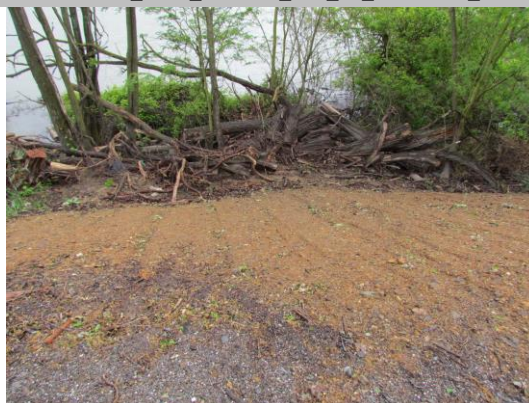
Photo 1 of 1 : SP_2017_RD0307_166_62_20170519_00110.jpg

RD 307 Levee mile 0.35 water side levee slope fallen cut up tree branches and tree sections placed at levee toe.

| Remove the encroachment from the levee toe waterside. | | | | | |

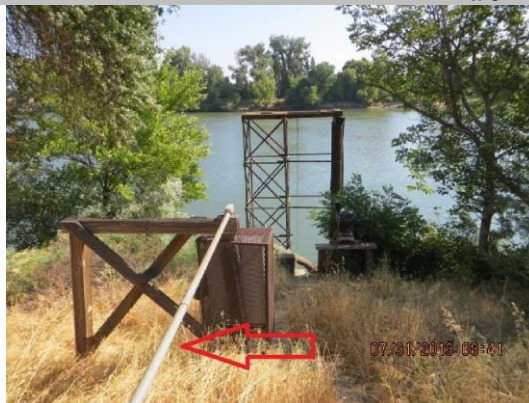
Photo 1 of 3 : UCIP_SP_2017_51632_28733.jpg

UCIP Comments: 12/07/2016 Same as last inspection. The bottom portion of the pipe has several holes through the wall. Recommend owner stop use of crossing. Owner will need to coordinate with CVFPB to comply with Title 23 requirements. (O. Magana - DWR UCIP)07/31/2013 Pipe heavily corroded and will likely need replacement if 15-inch pipe sleeved through it needs replacement. Annular space not grouted between two pipes. (W. Wylie - DWR UCIP) FIELD_STRUCT_DESC: 15-inch steel irrigation pipe through the levee, 16.7 feet below the crown. 15-inch pipe sleeved through an existing 20-inch pipe. 20-inch pipe first recorded in the 1964 USACE O&M Manual. Pump missing from abandoned steel pier located on the waterside (WS) toe. Walkway on the waterside (WS) from shoulder to pier missing or abandoned. Concrete U-shaped outlet with flap gate is located on the landside (LS) toe. Service pole located on the LS slope with anchor. [Additional Reference(s): DWR Levee Log, 1990. USACE Sacramento O&M Manual Unit 114, October 1964, (River Mile 48.53)]. FS Date: 12/7/2016

Abandoned walkway and metal pier on WS slope.

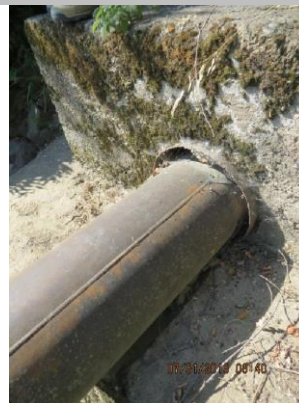
Photo 1 of 3 : UCIP_SP_2017_51444_28722.jpg

| FS_ID:51444 DS_ID:21656 EP_NO: N/A Repair Type: Urgent Crossing Status: Found UCIP Comments: 12/07/2016 Same as last inspection. The bottom portion of the pipe has several holes through the wall. Recommend owner stop use of crossing. Owner will need to coordinate with CVFPB to comply with Title 23 requirements. (O. Magana - DWR UCIP)07/31/2013 Pipe heavily corroded at outlet on LS toe. Holes on bottom of pipe at outlet and internal circumference shows heavy exfoliation. Pipe failing internally. Recommend replacement or video inspection before continuing use. (W. Wylie - DWR UCIP) FIELD_STRUCT_DESC: *DUPLICATE--DELETE* 1 of 2: 15-inch steel irrigation pipe sleeved through 21-inch steel conduit, through the levee 16.7 feet below crown. Slant pump, gate valve, concrete headwall, electrical control pane, and abandoned pier on WS slope. Concrete U-shaped outlet with flap gate on LS toe. Service pole on the landward slope with anchor. [Additional Reference(s): DWR Levee Log, 1990]. FS Date: 12/7/2016 | | | | | |

15-inch pipe sleeved through 21-inch pipe on WS slope at headwall.

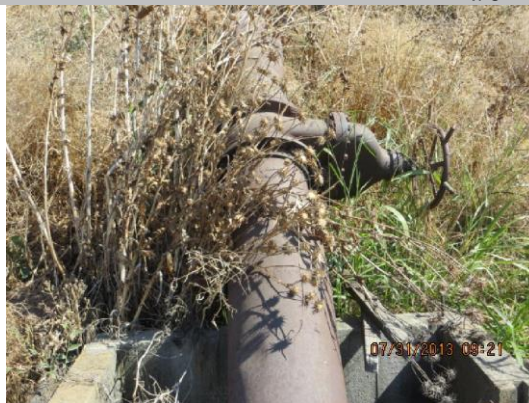
Photo 2 of 3 : UCIP_SP_2017_16764_28763.jpg

| UCIP Comments: Pipe rusted through at outlet on LS of shutoff valve. | | | | | | |
| This may be good indicator or corrosion throughout pipe. This is a good | | | | | | |

Pipe, gate valve, and concrete distribution box on LS toe.

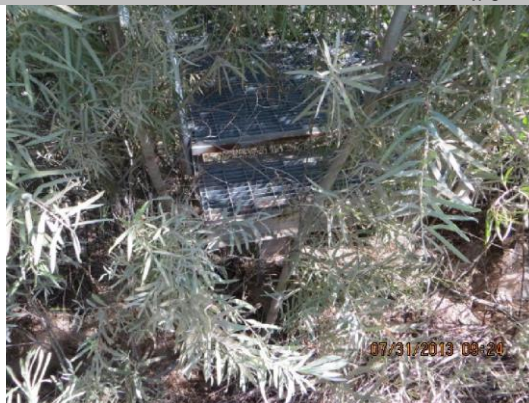
Photo 1 of 3 : UCIP_SP_2017_16766_28769.jpg

Metal walkway visible in brush on WS slope.

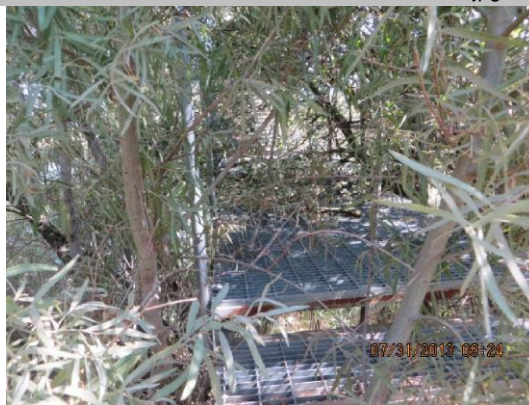
Photo 2 of 3 : UCIP_SP_2017_16766_28768.jpg

Metal walkway visible in brush on WS slope.

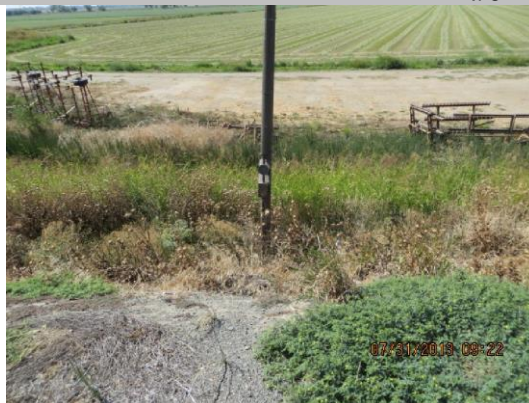
Photo 3 of 3 : UCIP_SP_2017_16766_28770.jpg

Conduit visible at base of JP on LS toe.

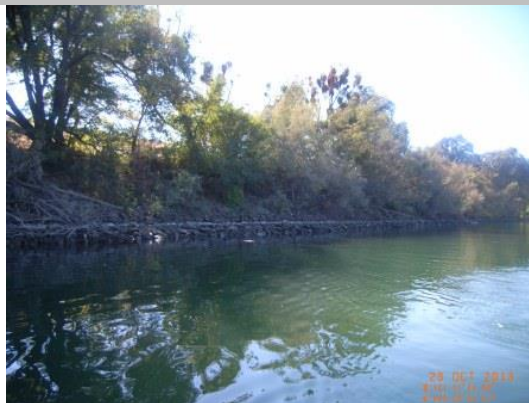
Photo 1 of 1 : SP_2017_RD0307_166_1_20170404_00001.jpg

| 2015: No observed changes. [2015 Site ID: SAC_48-6_R] | | | | | |

USACE 2013 Photo #1

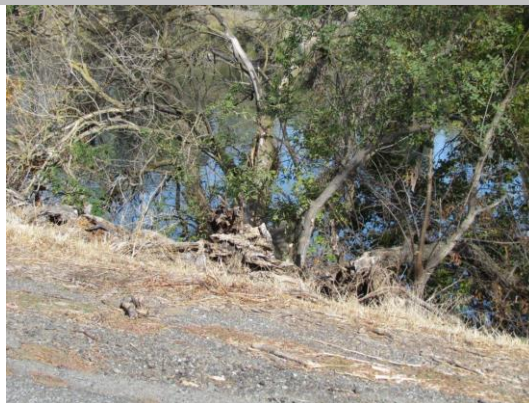
Photo 1 of 1 : SP_2017_RD0307_166_10_20170404_00007.jpg

Remove unwanted trees from waterside slope. These trees are dead and are resting on the slope. No change 4-17.

| The RD will schedule to have these trees cut up and removed from the waterside levee section as soon as possible. | | | | | |

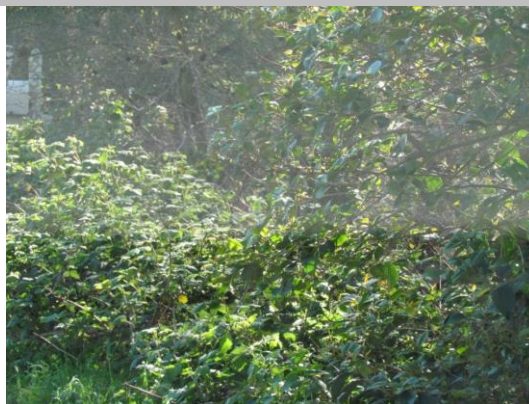
Photo 1 of 1 : SP_2017_RD0307_166_69_20170404_00019.jpg

Looking downstream from levee miles 1.59-1.66 slope covered in berry vines.

| Spray the berry vines present at this location. No change 4-17. | | | | | |

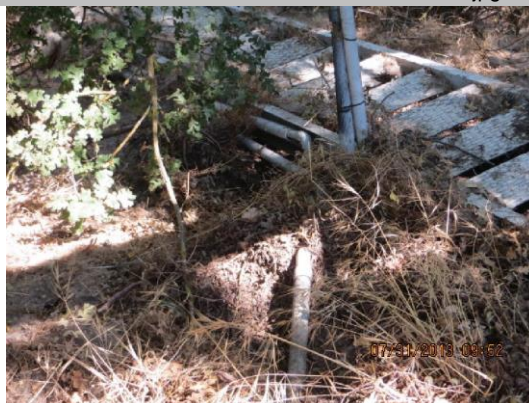
Photo 2 of 3 : UCIP_SP_2017_17105_29206.jpg

Pipes visible on WS shoulder at steel walkway.

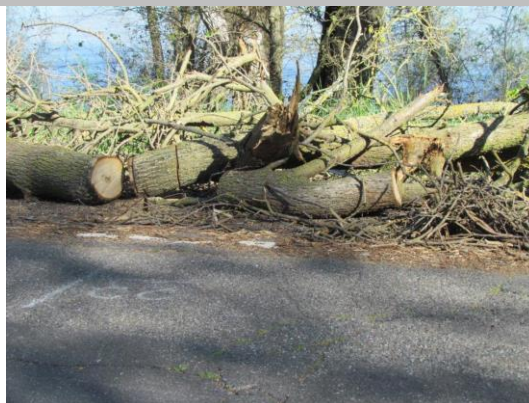
Photo 3 of 3 : SP_2017_RD0307_166_73_20170404_00022.jpg

Waterside shoulder levee mile 1.86 more of the cut up oak.

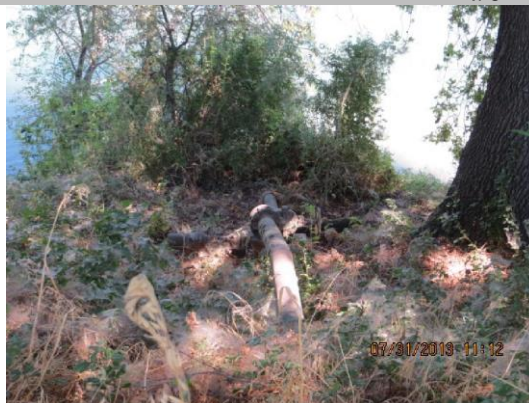
Photo 1 of 3 : UCIP_SP_2017_40794_28823.jpg

Pump and gate valve on WS slope.

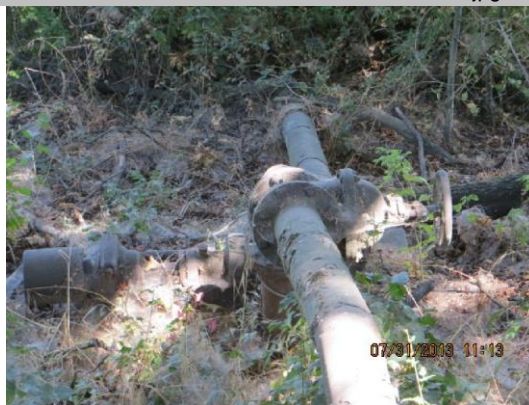
Photo 2 of 3 : UCIP_SP_2017_40794_28822.jpg

Pump and gate valve on WS slope.

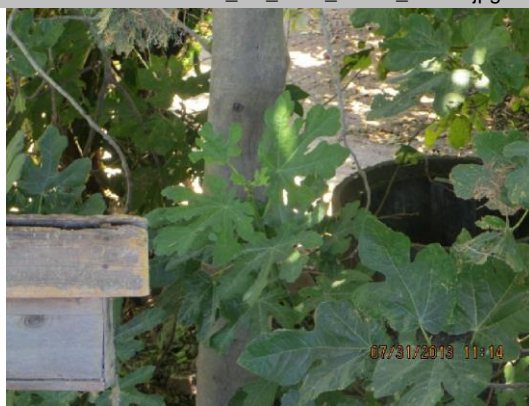
Photo 3 of 3 : UCIP_SP_2017_40794_28821.jpg

36-inch concrete standpipe on LS toe.

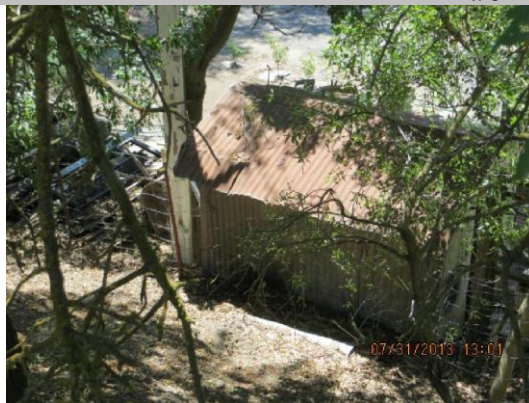
Photo 1 of 2 : UCIP_SP_2017_16843_28881.jpg

Pumphouse on LS toe. No access due to fence along toe.

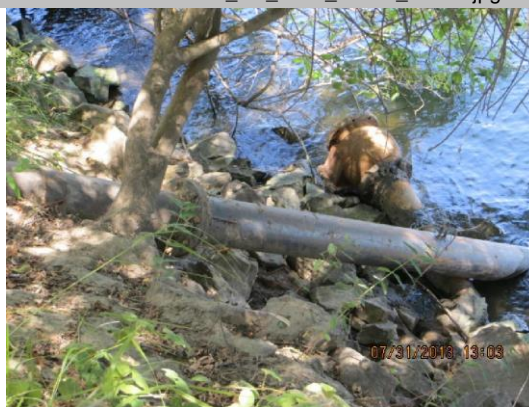
Photo 2 of 2 : UCIP_SP_2017_16843_28880.jpg

Pipe visible on WS toe.

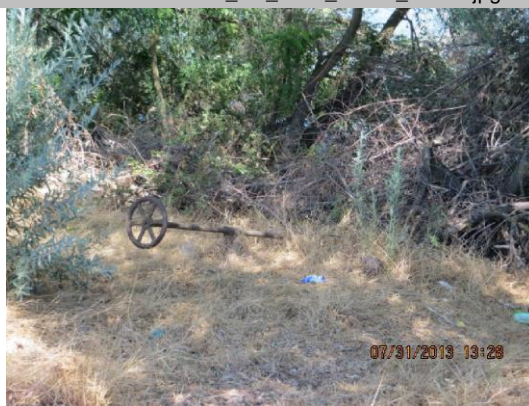
Photo 1 of 3 : UCIP_SP_2017_16923_28978.jpg

Gate valve actuator on WS slope.

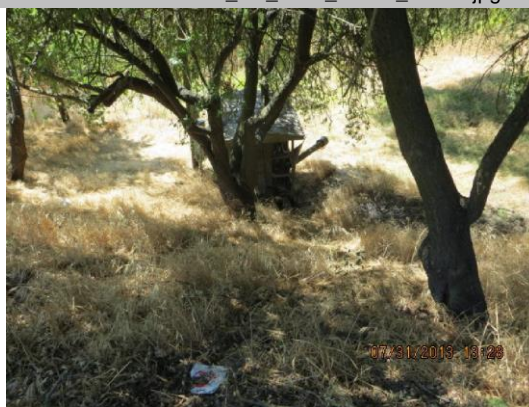
Photo 2 of 3 : UCIP_SP_2017_16923_28977.jpg

Pumphouse on LS toe.

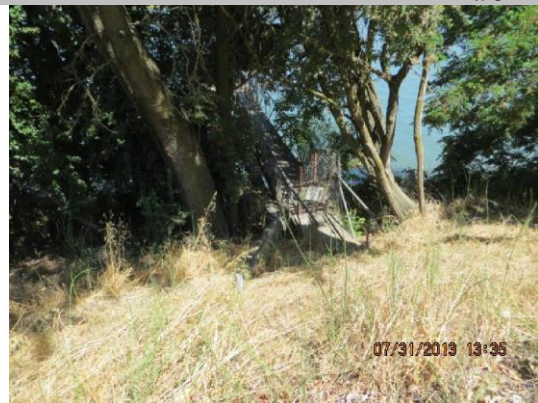
Photo 1 of 3 : UCIP_SP_2017_16924_28982.jpg

| FS_ID:16924 DS_ID:21680 EP_NO: 8030 Repair Type: Non-Urgent Crossing Status: Found UCIP Comments: Pipe not visible on LS slope or toe due to excessive vegetation. Vegetation should be cleared from pipe. FIELD_STRUCT_DESC: 1 of 2: 12-inch steel irrigation pipe through the levee 6-feet below the crown. Walkway on WS slope to a pump on a pile structure in the stream. JP and meter on LS toe. Pipe appears to cross levee at an angle. (Permit No. 8030, 1972). Included in the 1959 O&M manual. FS Date: 7/31/2013 | | | | | |

Pipe and walkway visible on WS slope.

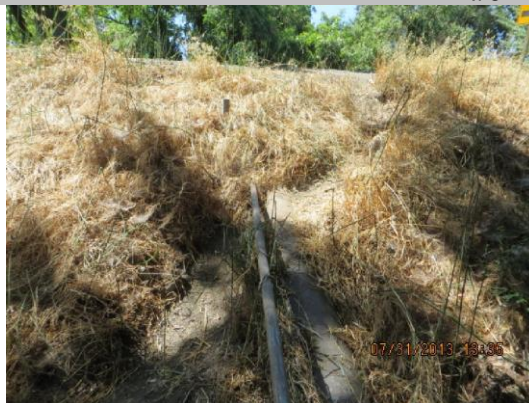
Photo 1 of 2 : UCIP_SP_2017_16925_28984.jpg

Conduit visible on WS slope.

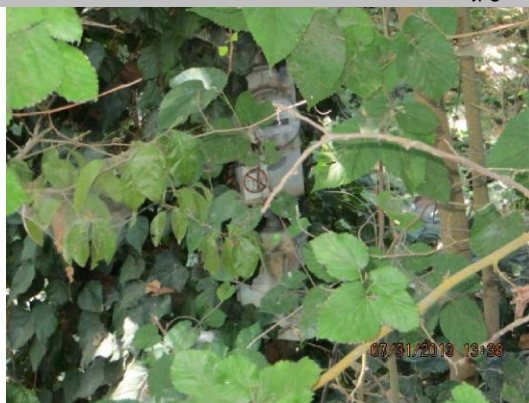
Photo 2 of 2 : UCIP_SP_2017_16925_28983.jpg

JP and meter on LS toe.

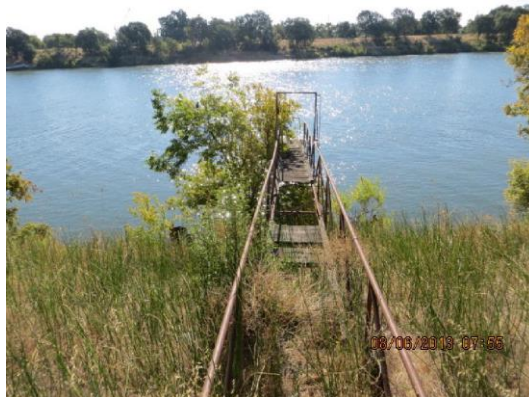
Photo 1 of 3 : UCIP_SP_2017_51445_29022.jpg

Metal walkway to pump on pier and gate valve actuator on WS slope.

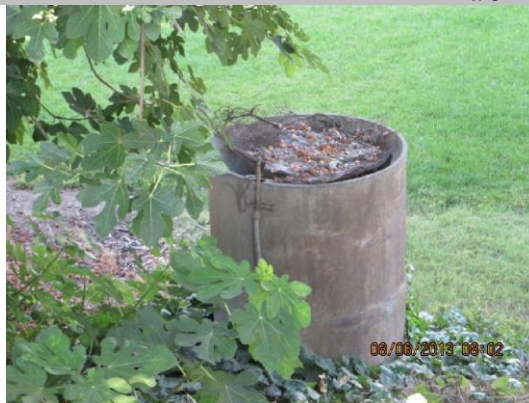
Photo 3 of 3 : UCIP_SP_2017_51445_29020.jpg

| FS_ID:51445 DS_ID:21682 EP_NO: 8034 Repair Type: Urgent Crossing Status: Found UCIP Comments: 12/07/2016 Crossing has been downgraded from Urgent to Non-Urgent pipe appears abandoned. Need to coordinate with owner to determine status of crossing. If crossing is abandoned, owner will need to coordinate with the CVFPB to comply with Title 23. (O. Magana - DWR UCIP)08/06/2013 Appears abandoned and should be done so properly. Walkway to pier is falling apart and is an attractive nuisance. Pipe rusted through at riser on LS toe. (W. Wylie - DWR UCIP) FIELD_STRUCT_DESC: *ABANDONED* 1 of 2: 14-inch steel irrigation pipe through the levee, 13 feet below the crown. Pump on pile structure with walkway located on waterside (WS) slope. Gate valve located on the WS toe and a 48-inch concrete standpipe located on the LS toe. Sheet pile wall around base of metal pier at WS toe (14-inch pipe first referenced in the USACE O&M Manual and later pipe authorized under Automatic Board Order (ABO) issued as Permit No. 8034, 1972 - Heringer). [Additional Reference(s): DWR Levee Log, 1990. USACE Sacramento O&M Manual Unit 114, October 1964 (River Mile 45.67)]. FS Date: 12/7/2016 | | | | | | |

48-inch concrete standpipe on LS toe.

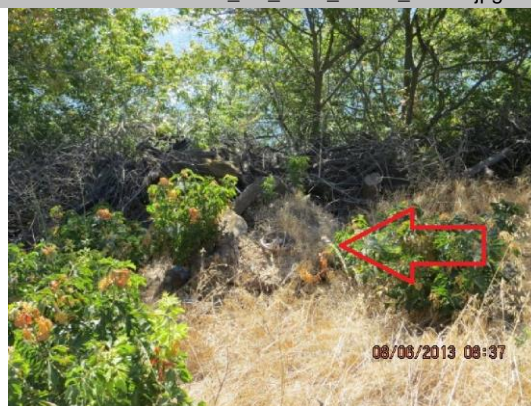
Photo 1 of 3 : UCIP_SP_2017_51446_29261.jpg

Wooden lid at gate valve in CMP riser on WS slope.

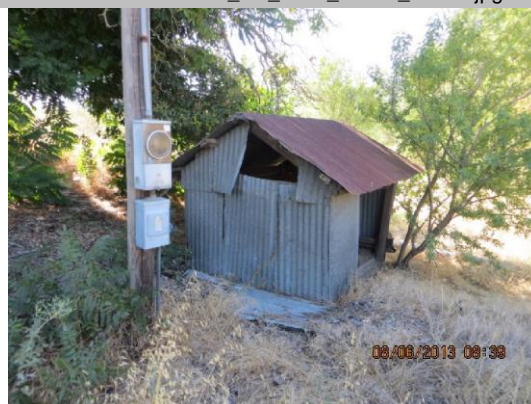
Photo 2 of 3 : UCIP_SP_2017_51446_29260.jpg

Power Pole, meter, and pumphouse on LS toe.

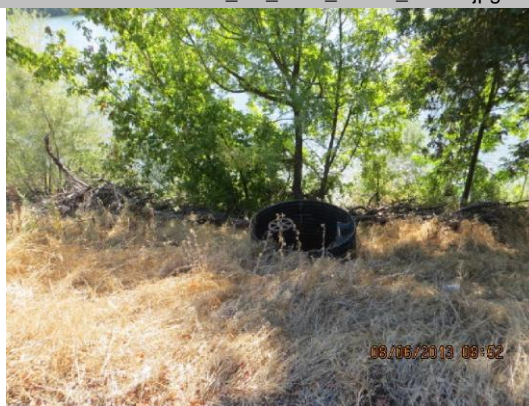
Photo 1 of 3 : UCIP_SP_2017_22670_38290.jpg

Slide gate in riser on WS slope.

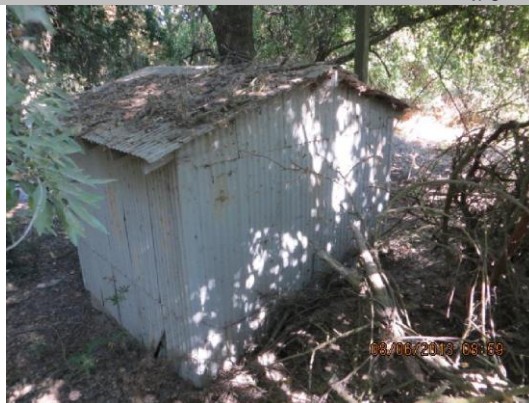
Photo 3 of 3 : UCIP_SP_2017_22670_38292.jpg

Pumphouse on LS toe.

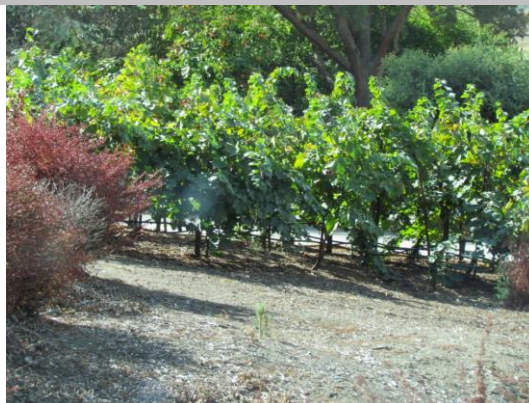
Photo 1 of 1 : SP_2017_RD0307_166_27_20170404_00009.jpg

| There are grapes planted on the levee slope landside without permit from the CVFPB. This issue has been reported and recorded in previous inspections. | | | | | |

Unwanted grapes placed on levee slope, these grapes has been reported to both district and CVFPB. No permit.

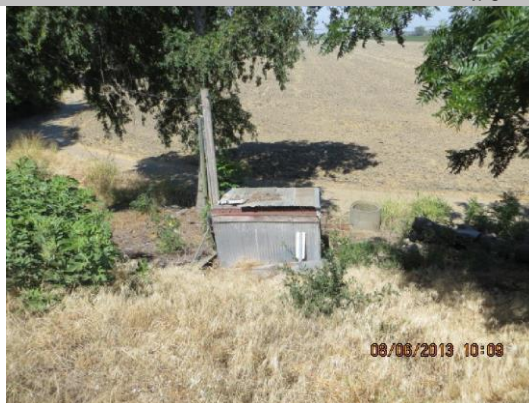
Photo 1 of 3 : UCIP_SP_2017_17183_29321.jpg

| FS_ID:17183 DS_ID:21690 EP_NO: 8041 Repair Type: Non-Urgent Crossing Status: Found UCIP Comments: Pipe appears abandoned and should be done so properly. Gate valve has been removed from pipe on LS toe. FIELD_STRUCT_DESC: 6-inch steel irrigation pipe through the levee 13.5 feet below the crown. Pump and-gate valve in pump house on the landward slope. Gate valve on WS slope. Service pole and anchor on the landward slope (Permit No. 8041, 1972). Included in the 1959 O&M manual. FS Date: 8/6/2013 | | | | | |

Pumphouse for 6-inch pipe at LS toe.

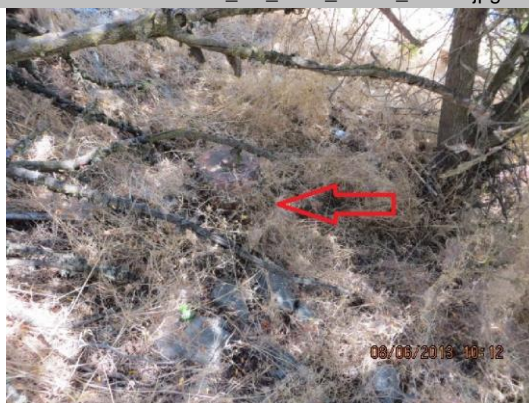
Photo 2 of 3 : UCIP_SP_2017_17183_29320.jpg

Gate valve on WS slope.

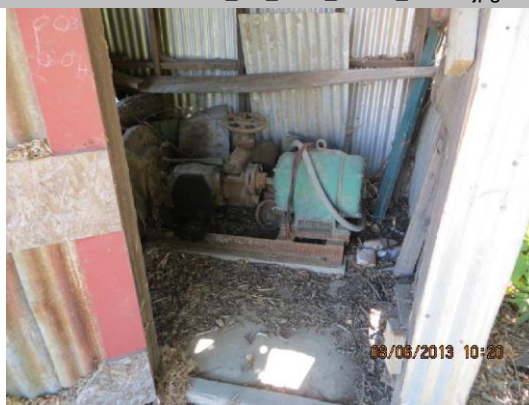
Photo 3 of 3 : UCIP_SP_2017_17183_29323.jpg

Pump in pumphouse on LS toe.

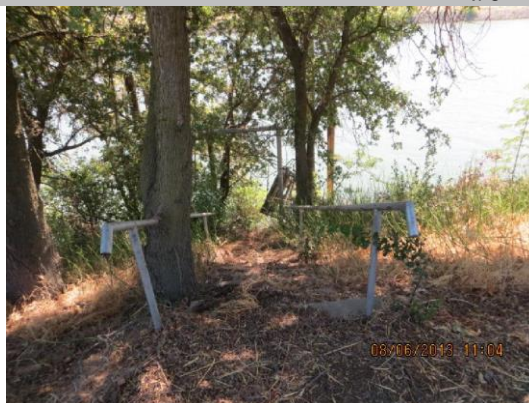
Photo 1 of 3 : UCIP_SP_2017_17184_29326.jpg

| FS_ID:17184 DS_ID:21691 EP_NO: 8561 Repair Type: Non-Urgent Crossing Status: Found UCIP Comments: Pipe abandoned and should be done so properly. Gate valve on LS toe broken. FIELD_STRUCT_DESC: 10-inch steel irrigation pipe through the levee 12.8 feet below the crown. Pump, gate valve, and 6'X8' concrete distribution box on LS toe. Gate valve on the waterward slope (Permit No. 8561, 1973). Included in the 1959 O&M manual. FS Date: 8/6/2013 | | | | | |

Pipe and gate valve on WS slope just downstream from stairs.

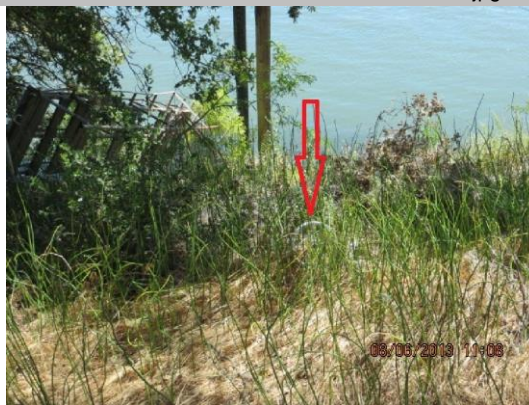
Photo 3 of 3 : UCIP_SP_2017_17184_29324.jpg

Gate valve actuator on WS slope.

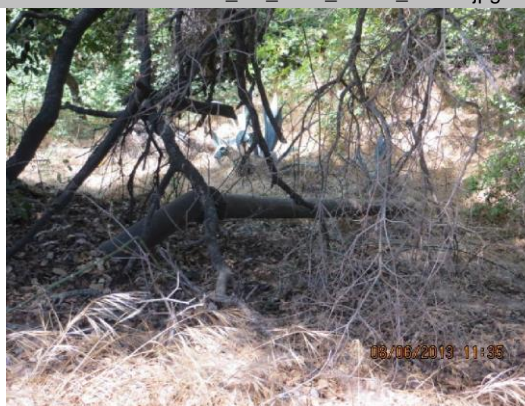
Photo 1 of 1 : UCIP_SP_2017_22671_38293.jpg

| FS_ID:22671 DS_ID:21693 EP_NO: N/A Repair Type: Non-Urgent Crossing Status: Found UCIP Comments: Pipe abandoned and should be done so properly. FIELD_STRUCT_DESC: 1 of 2: 6-inch steel irrigation pipe through the levee 1.5 feet below the crown Originally included in the 1959 O&M manual. FS Date: 8/6/2013 | | | | | |

Pipe visible on LS slope.

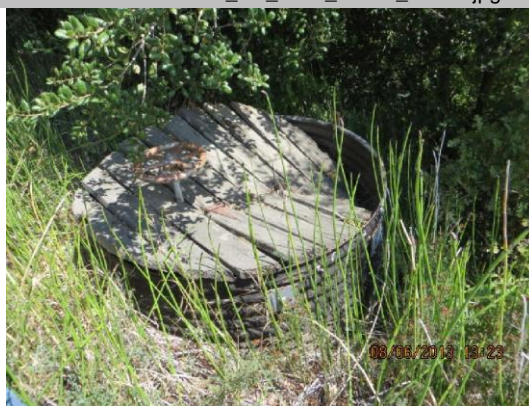
Photo 1 of 3 : UCIP_SP_2017_22710_38415.jpg

| FS_ID:22710 DS_ID:21698 EP_NO: 8048 Repair Type: Non-Urgent Crossing Status: Found UCIP Comments: Pipe appears abandoned and should be done so properly. FIELD_STRUCT_DESC: 6-inch steel irrigation pipe through levee 14.5 feet below crown. Gate valve in 5-foot diameter CMP riser on the WS slope. Pump and gate valve in pumphouse on LS toe. 36-inch concrete standpipe on LS of pumphouse (Permit No. 8048, 1972). Included in the 1959 O&M manual. FS Date: 8/6/2013 | | | | | |

Gate valve in 5-foot diameter CMP riser on WS slope.

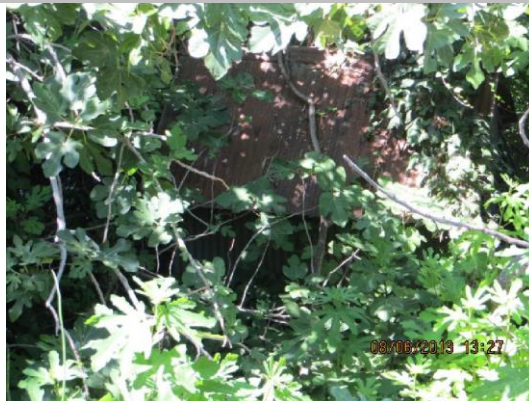
Photo 3 of 3 : UCIP_SP_2017_22710_38413.jpg

Pumphouse on LS toe.

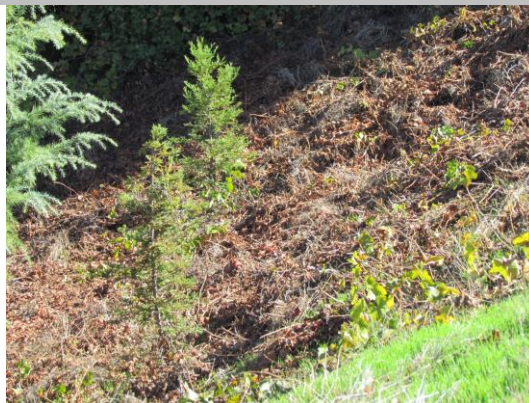
Photo 1 of 5 : SP_2017_RD0307_166_28_20170404_00010.jpg

RD 307 looking back upstream at the levee toe and slope are young unauthorized red woods and one taller redwood planted prior to this inspection.

| Unauthorized planting of small oleander trees on the shoulder and young fig trees placed on the landside levee toe. Remove these encroachments. Pending. | | | | | |

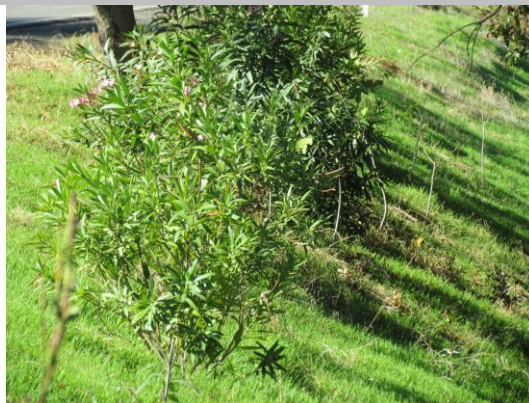
Photo 3 of 5 : SP_2017_RD0307_166_28_20170404_00012.jpg

RD 307 Landside looking downstream top of slope, unauthorized planting of young oleanders and young fig trees.

| Unauthorized planting of small oleander trees on the shoulder and young fig trees placed on the landside levee toe. Remove these encroachments. Pending. | | | | | | |

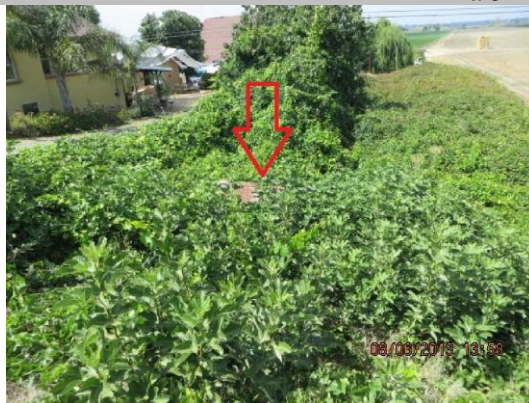
Photo 1 of 2 : UCIP_SP_2017_40546_29421.jpg

Pumphouse on LS toe.

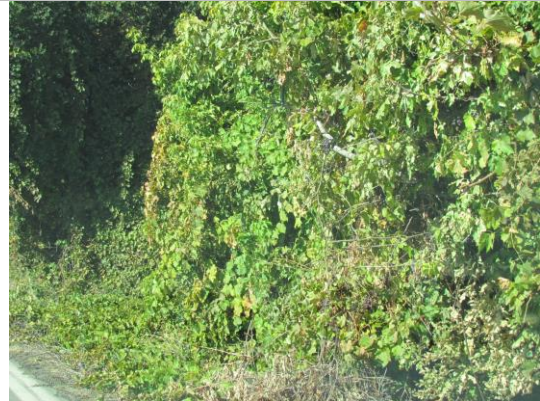
Photo 1 of 1 : SP_2017_RD0307_166_66_20170404_00018.jpg

RD 307 levee mile 5.39-5.49 landside shoulder and slope. Nochange.

| Control the wild grapes from the landside levee slope and shoulder. No change. | | | | | |

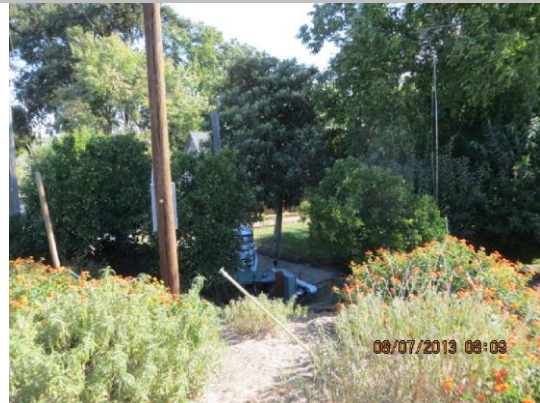
Photo 1 of 3 : UCIP_SP_2017_17287_29423.jpg

| FS_ID:17287 DS_ID:21701 EP_NO: 8050 Repair Type: Non-Urgent Crossing Status: Found UCIP Comments: Lid damaged on 5ft diameter riser on WS slope. Good candidate for video inspection as repair to pipe on LS toe is good indicator that pipe is failing internally. FIELD_STRUCT_DESC: 8-inch steel irrigation pipe through the levee 12.7 feet below the crown. Pump, vent, butterfly valve, 36-inch concrete standpipe, and power pole at LS toe. Gate valve in 5-foot diameter CMP riser on waterward slope (Permit No. 8050, 1972). Included in the 1959 O&M manual. FS Date: 8/7/2013 | | | | | |

Pump and appurtenances on LS toe.

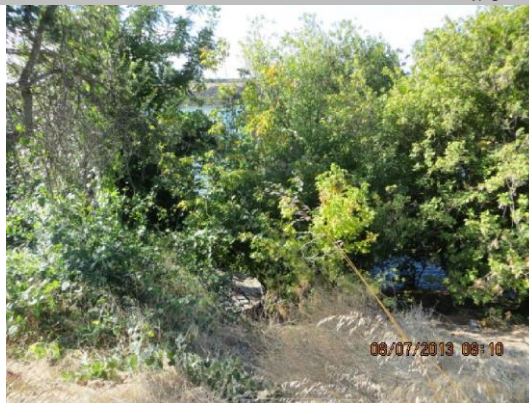
Photo 2 of 3 : UCIP_SP_2017_17287_29422.jpg

| UCIP Comments: Lid damaged on 5ft diameter riser on WS slope. | | | | | | |

Gate valve in 5-foot diameter CMP riser on WS slope.

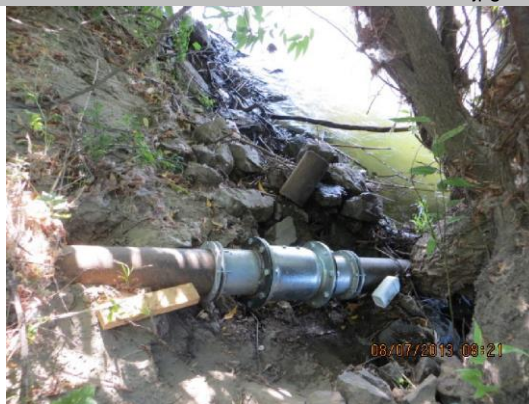
Photo 3 of 3 : UCIP_SP_2017_17287_29425.jpg

Pipe visible at WS toe.

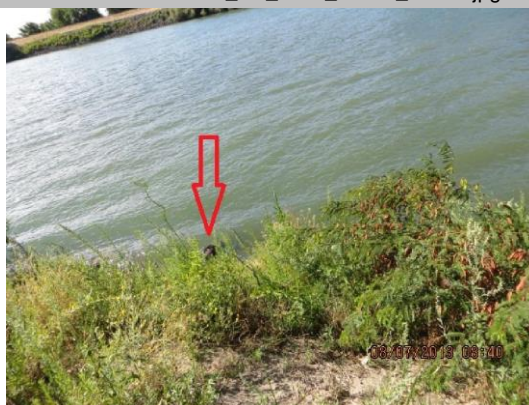
Photo 1 of 3 : UCIP_SP_2017_17343_29442.jpg

| FS_ID:17343 DS_ID:21702 EP_NO: 8051 Repair Type: Non-Urgent Crossing Status: Found UCIP Comments: Annular space between pipes does not appear to be grouted. FIELD_STRUCT_DESC: 10-inch steel irrigation pipe through the levee 16.8 feet below the crown. Pump, vent, Power pole, and gate valve on the LS toe. 36-inch concrete standpipe next to pump on LS toe (Permit No. 8051, 1972). 8-inch steel pipe sleeved through 10-inch. Originally included in the 1959 O&M manual. FS Date: 8/7/2013 | | | | | |

Pipe visible on WS toe.

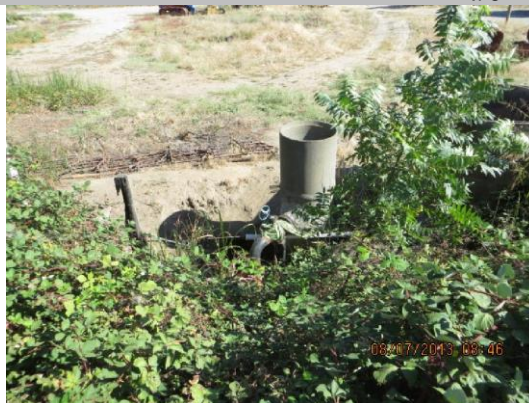
Photo 2 of 3 : UCIP_SP_2017_17343_29441.jpg

Pump, butterfly valve, vent, and concrete standpipe on LS toe.

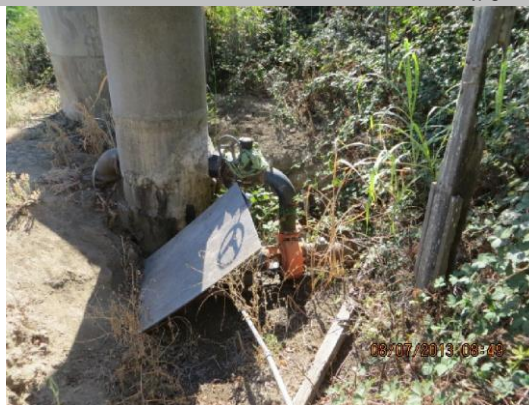
Photo 3 of 3 : UCIP_SP_2017_17343_29440.jpg

Pump, butterfly valve, vent, and concrete standpipe on LS toe. Photo 3 description or comment here.

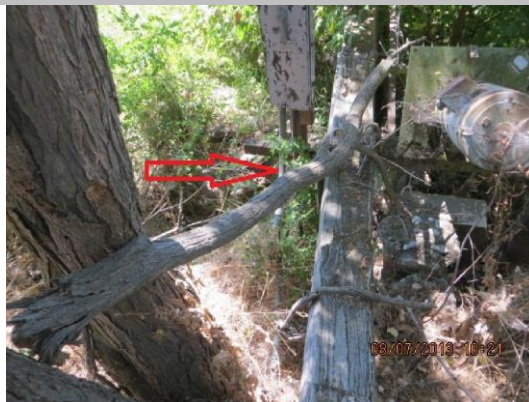
Photo 2 of 2 : UCIP_SP_2017_22711_38418.jpg

Electrical conduit visible at panel next to slant pump on WS slope.

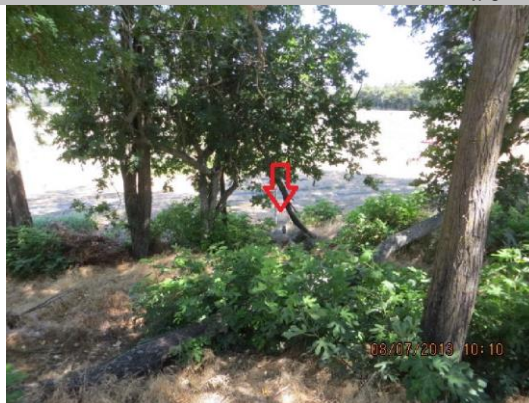
Photo 1 of 3 : UCIP_SP_2017_22712_38422.jpg

| FS_ID:22712 DS_ID:21732 EP_NO: 8053 Repair Type: Non-Urgent Crossing Status: Found UCIP Comments: Annular space between pipes does not appear to be grouted. FIELD_STRUCT_DESC: 20-inch steel irrigation pipe through the levee 14.7 feet below the crown. 16-inch pipe sleeved through 20-inch. Slant pump and gate valve on the waterward slope. Gate valve, power pole, and electric panel on LS toe (Permit No. 8053, 1972). Originally included in the 1959 O&M manual. FS Date: 8/7/2013 | | | | | |

Pipe on LS toe.

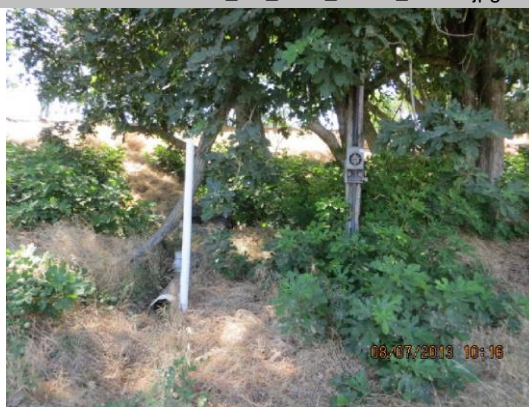
Photo 2 of 3 : UCIP_SP_2017_22712_38421.jpg

Pipe, power pole, and meter on LS toe.

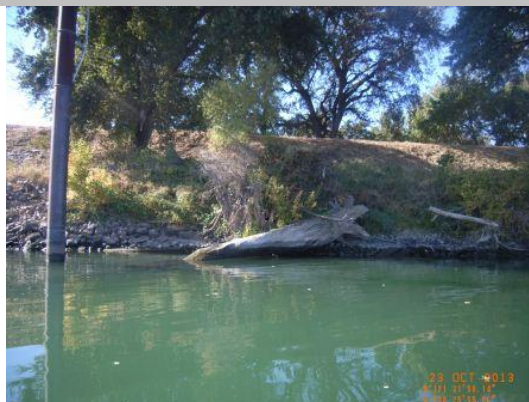
Photo 1 of 1 : SP_2017_RD0307_166_2_20170404_00002.jpg

| 2008 - Large rotational failure in bank and well into the levee slope. Could be a significant problem in the next high flow event. 2009 - Minimal new erosion, site extended upstream. 2010 - Minor new erosion. 2011 - Tree popout has left a large hole. Large slump area. Rock on the bank is failing in some locations. 2012 - The toe appears to be scouring out. 2015: No observed changes. [2015 Site ID: SAC_43-2_R] | | | | | |

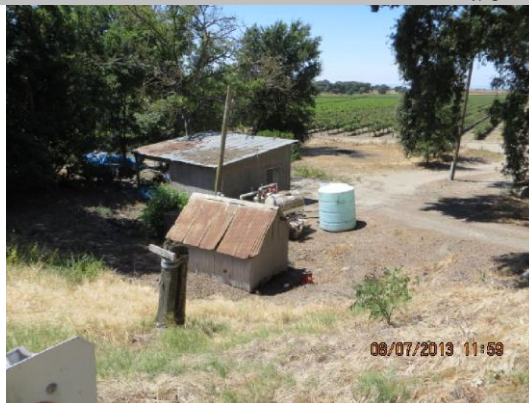
Photo 1 of 3 : UCIP_SP_2017_17385_29489.jpg

Pump and gate valve inside pumphouse on LS toe.

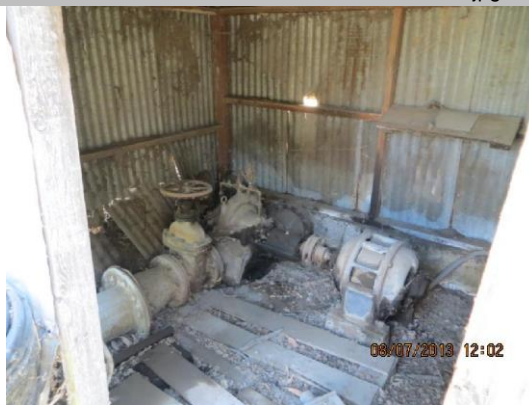
Photo 2 of 3 : UCIP_SP_2017_17385_29488.jpg

Pump and gate valve inside pumphouse on LS toe.

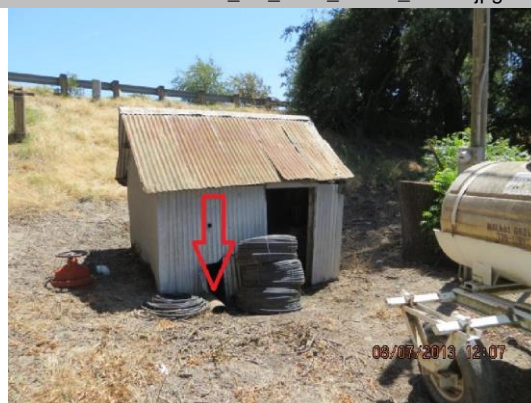
Photo 3 of 3 : UCIP_SP_2017_17385_29487.jpg

Pipe cut and open on LS of pumphouse.

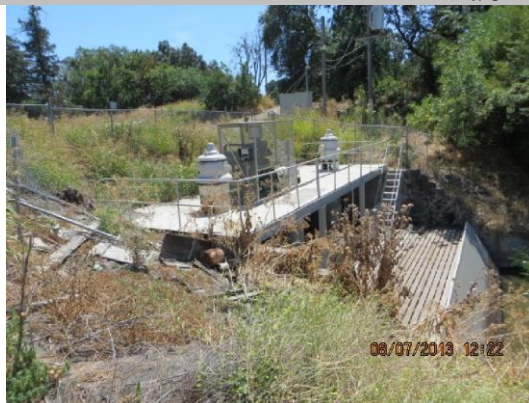
Photo 3 of 3 : UCIP_SP_2017_17404_29502.jpg

Pumping plant and trash rack off LS toe.

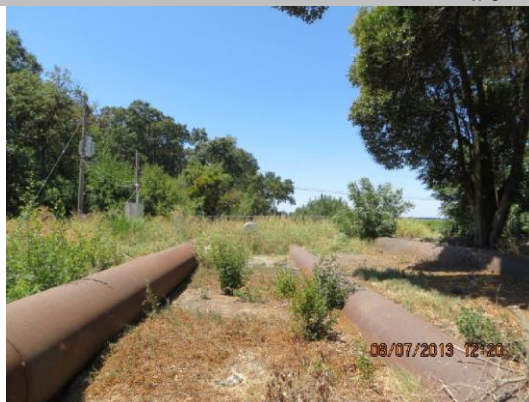
Photo 1 of 3 : UCIP_SP_2017_17406_29510.jpg

Pipes visible on LS toe.

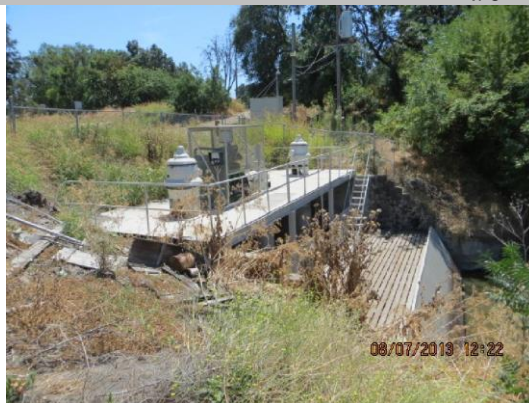
Photo 2 of 3 : UCIP_SP_2017_17406_29509.jpg

Pump and trash rack 200-feet off LS toe.

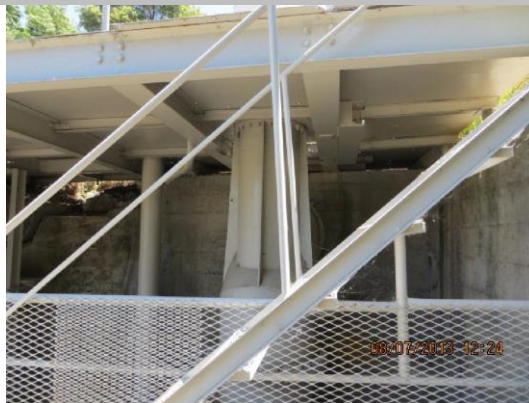
Photo 3 of 3 : UCIP_SP_2017_17406_29508.jpg

| LM Start | 6.54 | Rating ** | A/W | Issue No. | 122 (cont) |

Intake at concrete headwall under pump.
